EGYPTIAN CIVIL AVIATION AUTHORITY

REPORT OF INVESTIGATION OF ACCIDENT

EgyptAir Flight 990

Boeing 767-300ER SU-GAP

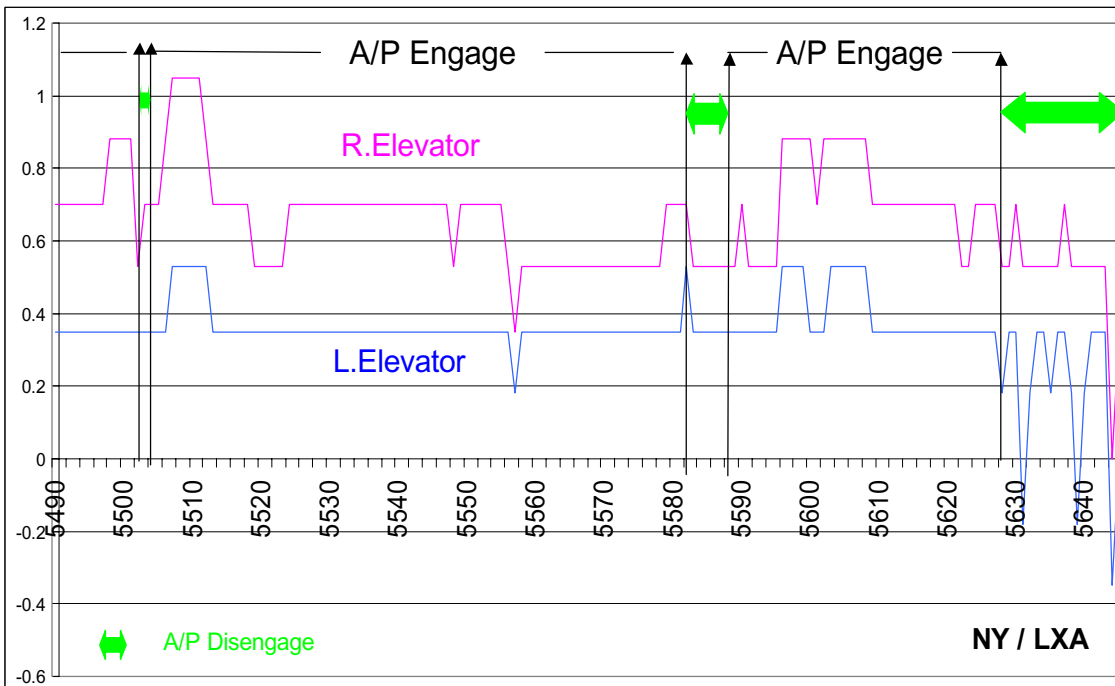
The Captain of Flight 989 reported that he had disengaged the autopilot in the four cases in response to a sudden movement of the control column (control column displacement parameter is not recorded in FDR). Figure 4 below shows the elevator behavior just after autopilot disengagement in three cases.

Figure 4 Elevator movements with autopilot disengagements, Flight NY/LAX

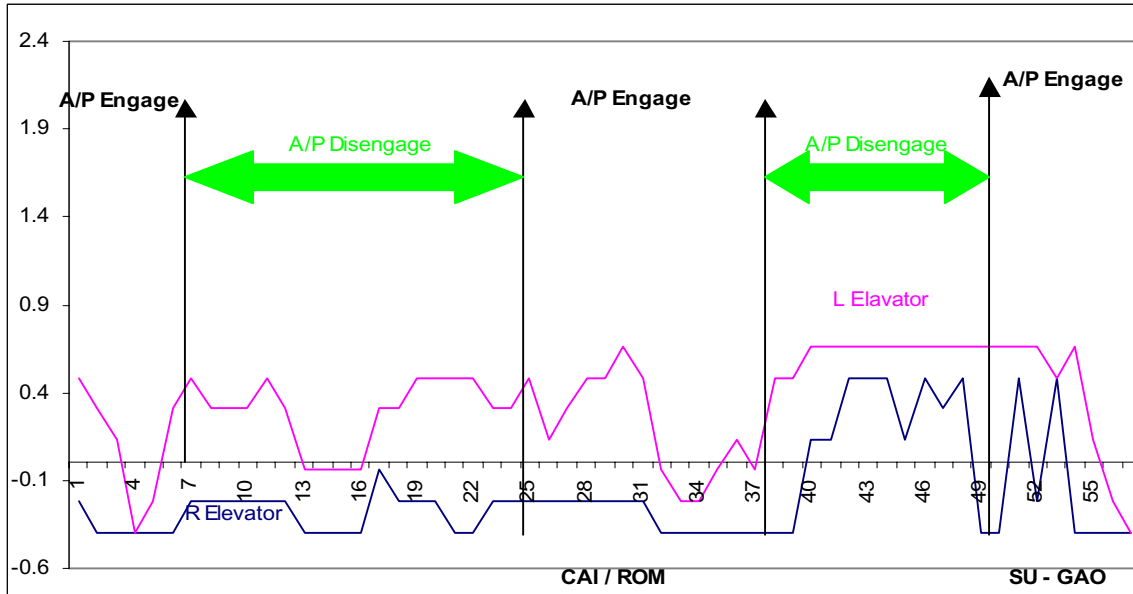
This elevator movement was compared with elevator motion following the autopilot disconnect during a flight from Rome to Cairo on the sister B-767. SU-GAO. The FDR was analyzed after the flight for elevator behavior and all other flight controls. Elevator movement was different (see figure 5) on the test flight in comparison with the accident.

Figure 5 Elevator movements with autopilot disengagements, Flight CAI/ROM

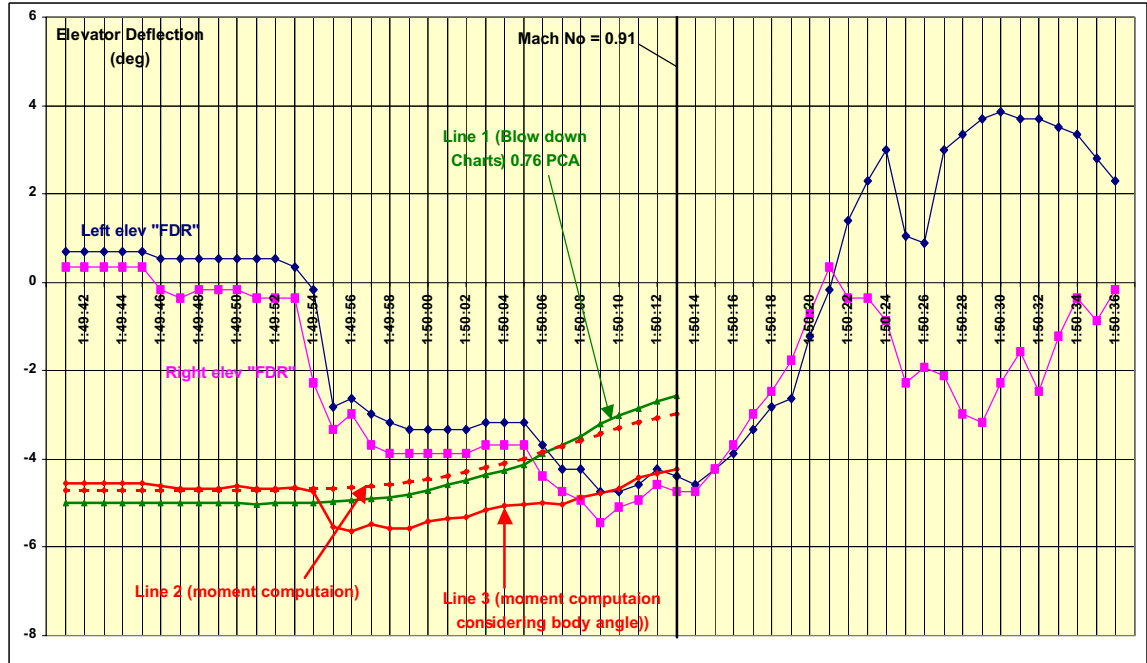
Figure 27 shows the recorded FDR elevator positions compared with the positions calculated using several techniques, all of which were based on Boeing documents. Line 1 in this figure shows the resulting elevator deflection from the elevator blowdown chart for an equivalent of 0.76 PCA for the appropriate flight condition.²¹ Lines 2 and 3 show the resulting elevator displacement using elevator moment calculation based on hinge moment coefficients at appropriate stabilizer position, elevator deflection, and Mach number. Line 2 is the result when the body angle of attack is assumed to be constant at a

Figure 27 Right elevator blowdown with dual PCA valve jam failure

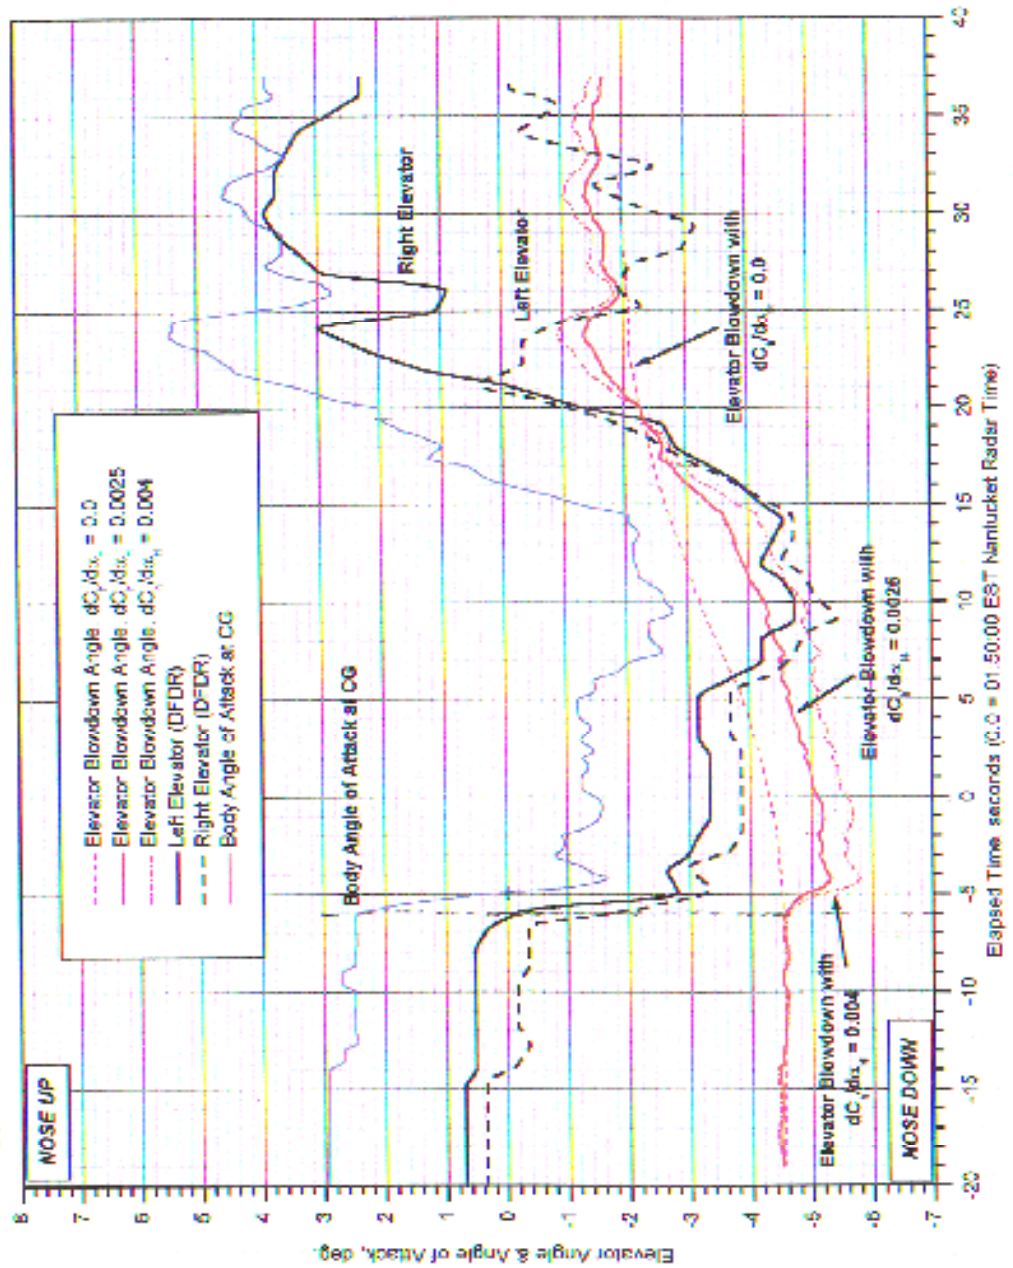
For comparison, refer to Figure 28, which was prepared by the NTSB Performance Group Chairman. It shows very close agreement with Figure 27.

Figure 28. EgyptAir 990 Elevator Blowdown Angles, Dual PCA Failure Scenario (NTSB)

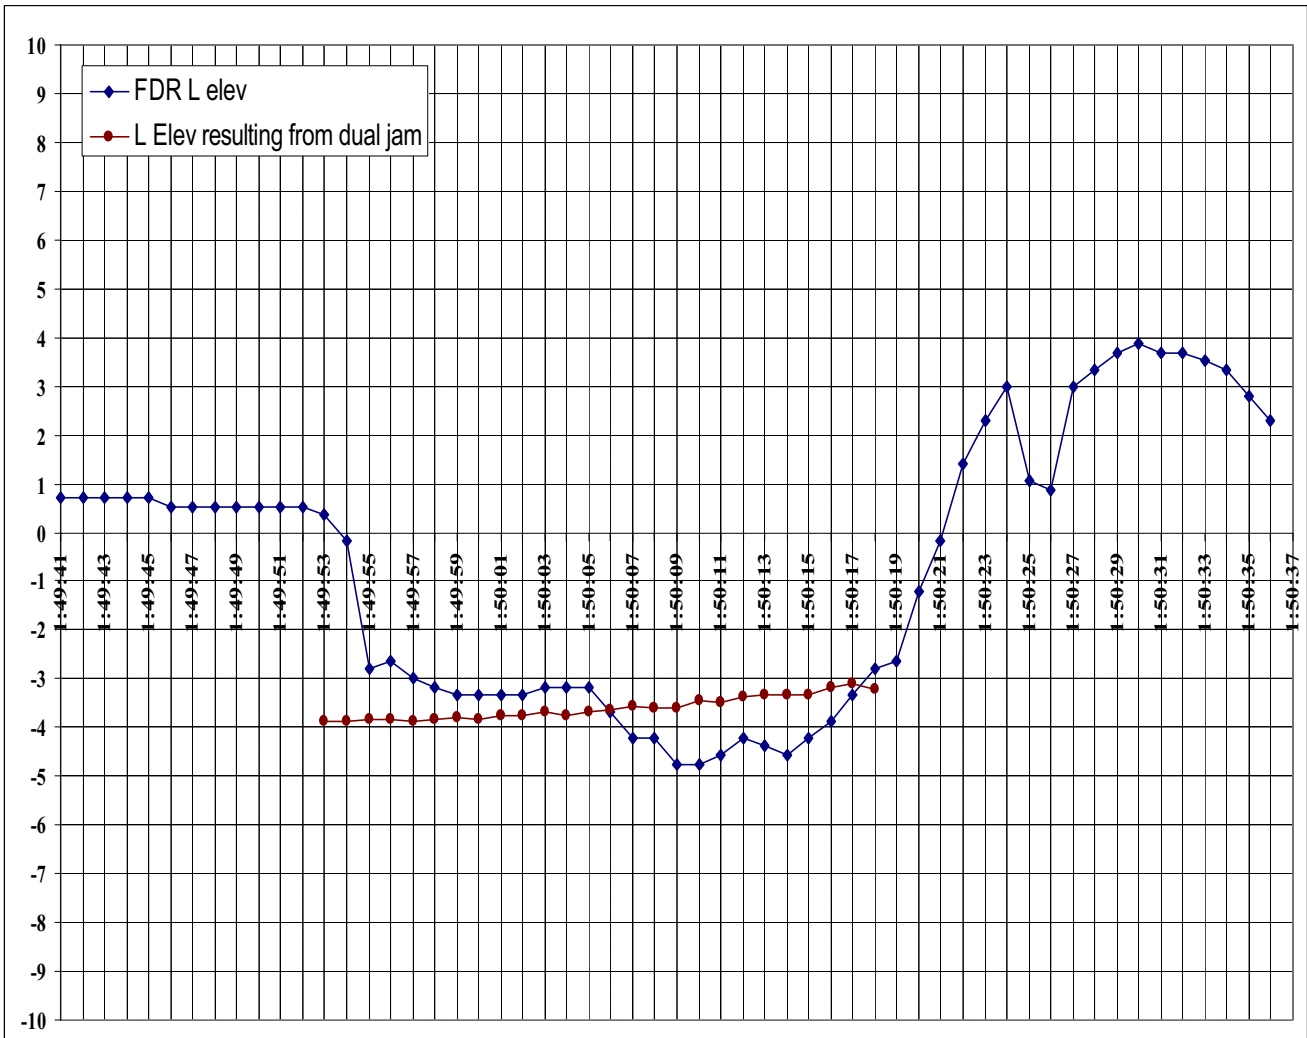
Figure 29 shows the left elevator deflection as recorded by the FDR and the resulting left elevator deflection due to the 30 pound induced force at the given flight condition.²³

Fig 29 Left elevator deflection with dual PCA valve jam on right side

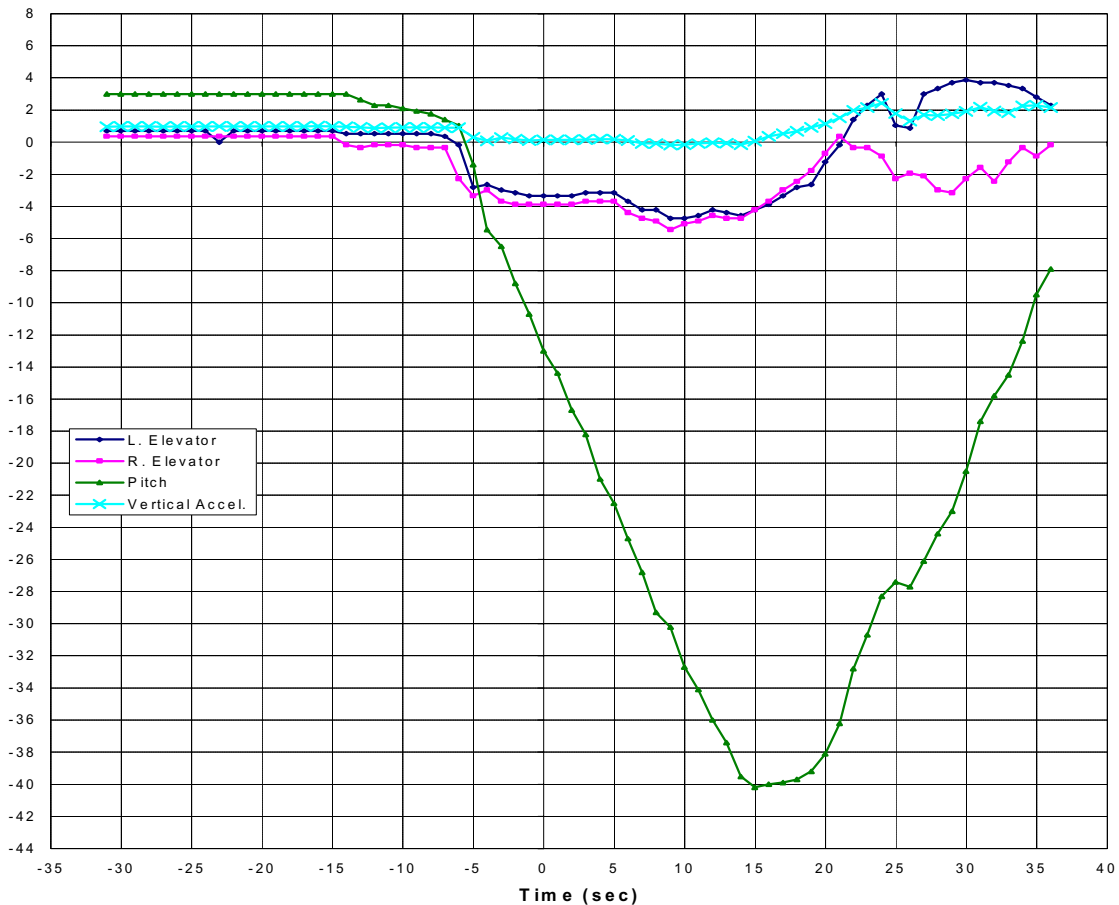
accompanied by a decrease in the vertical load factor of about 0.07 “g.” At the same time, the pitch attitude began to decrease (see Figure 30, elapsed time at the x-axis is selected to be 0 at time 1:50:00 ET). The correlation of elevator movement with vertical load factor and pitch change confirms that the recorded elevator deflection did actually occur. This deflection of the elevators with the right elevator leading is what one would expect if one PCA had jammed in the TED position.³⁰

Figure 30 FDR Elevator Deflections, Pitch, and Vertical Acceleration

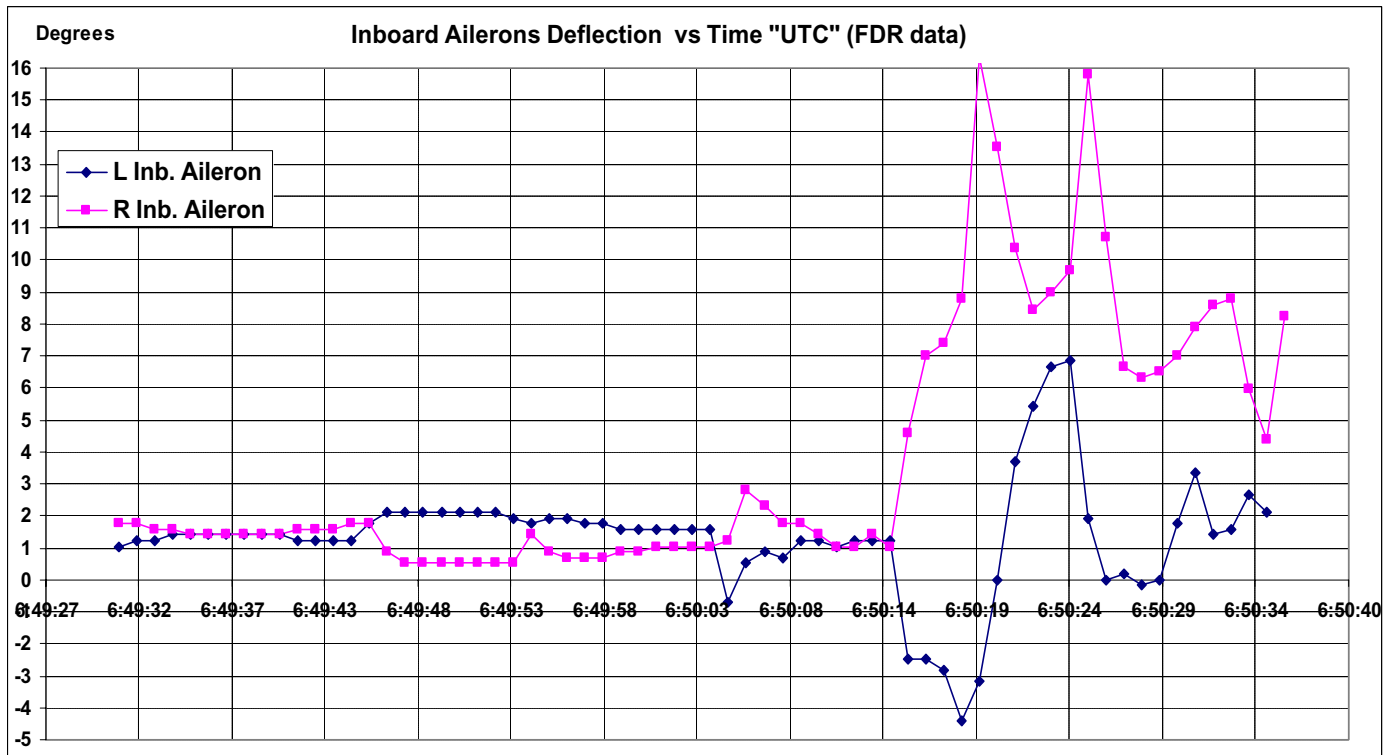
Normally, the left and right inboard ailerons move in directions opposite to each other. As shown in Figure 31 prior to approximately 01:50:19, the two inboard ailerons were moving in opposite directions. However, after this time, the left inboard aileron

Figure 31 Inboard Ailerons deflection vs. Time "UTC" (FDR data)

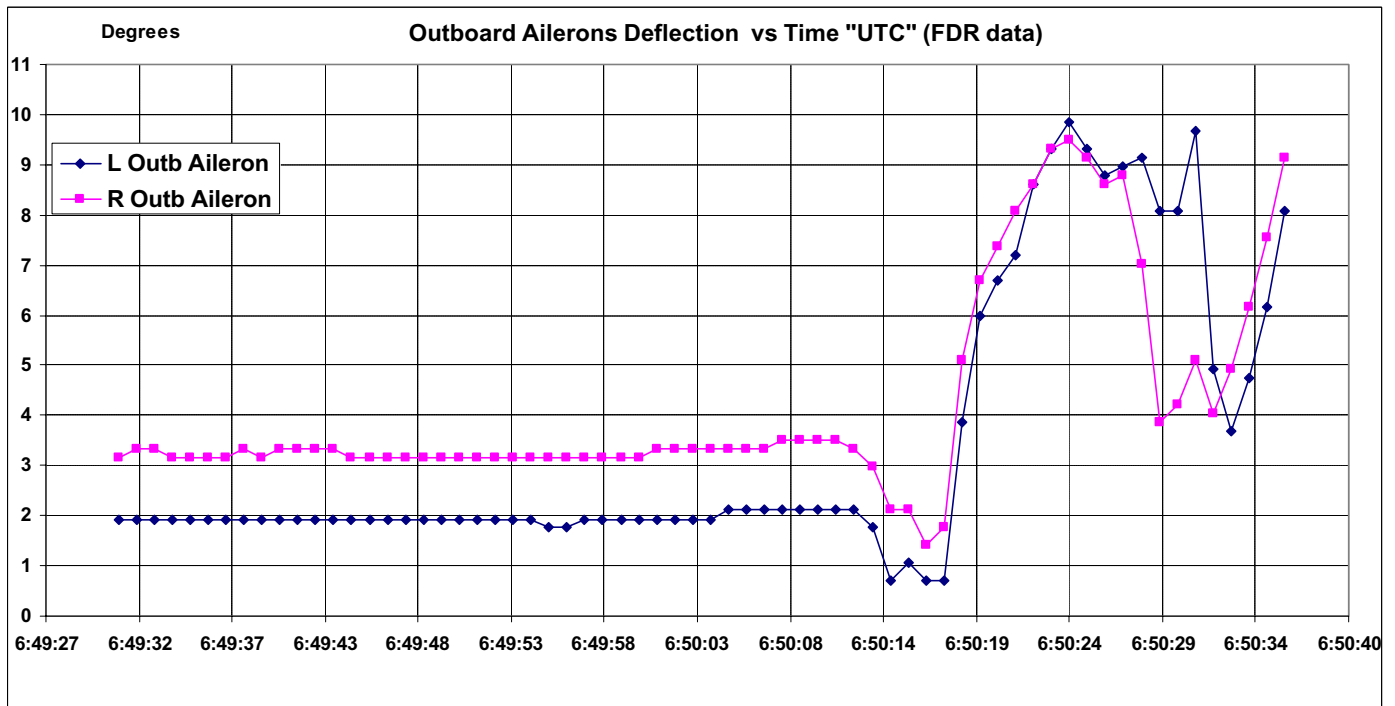
The outboard ailerons are designed so as to be locked at higher altitudes and higher Mach numbers, as was the case just before and during the dive. However, as shown in Figure 32, both left and right outboard ailerons showed large deflections in the trailing edge up direction. Moreover, both outboard ailerons showed an offset of more than four degrees close to the end of the dive. None of these outboard aileron movements can be commanded from the cockpit.

Figure 32 Outboard Ailerons deflection vs. Time "UTC" (FDR data)

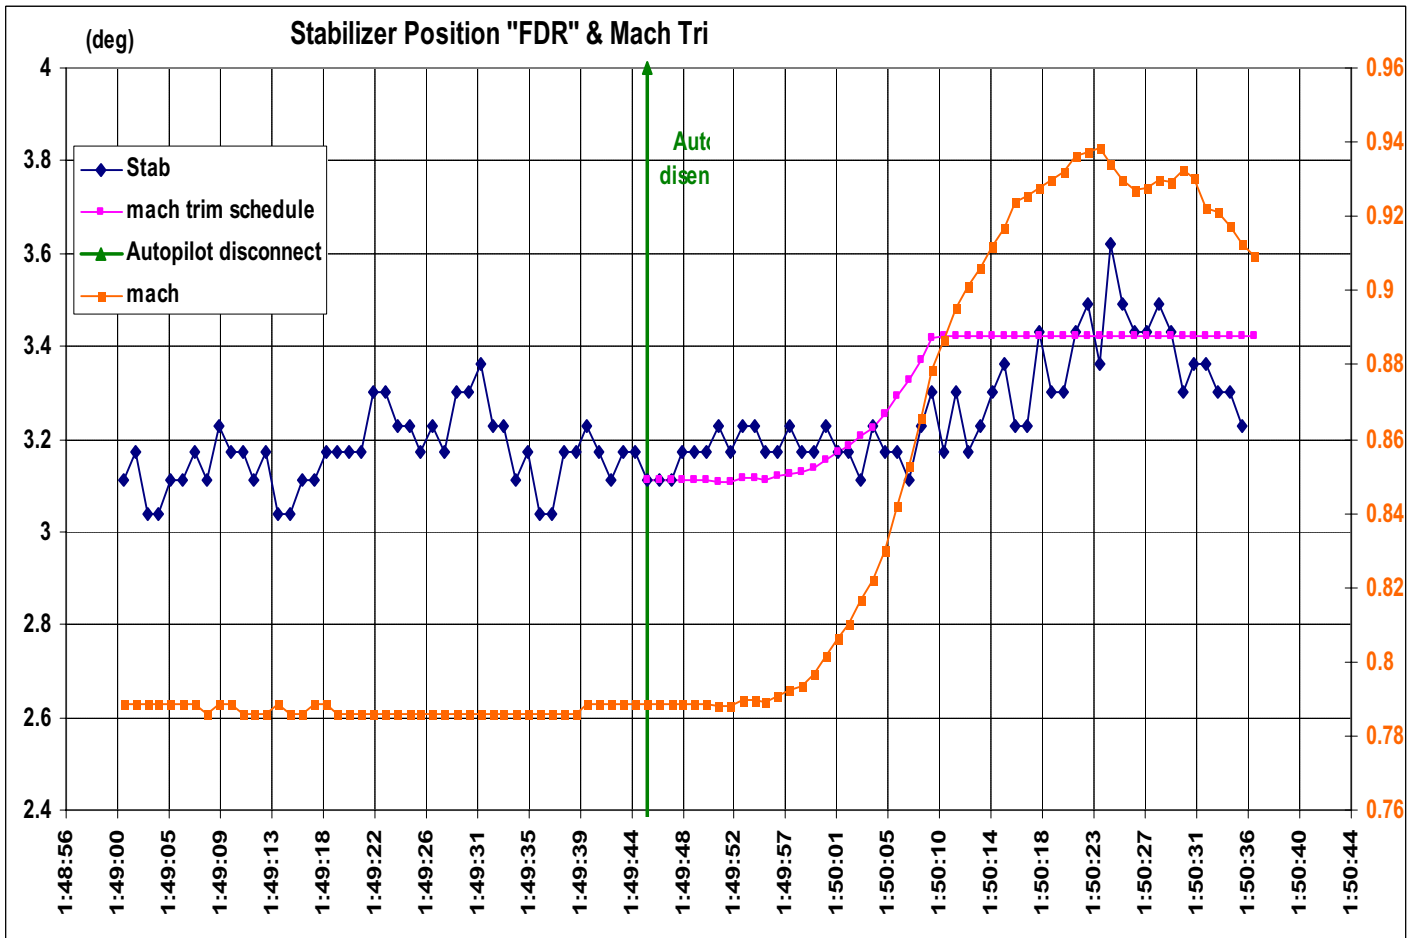
Figure 33 shows the FDR stabilizer position near the end of the FDR recording as well as the Mach number as derived from the recorded Calibrated Airspeed (CAS). The figure also shows the computed nose up stabilizer command generated by Mach Trim Speed logic, which is based on the Mach number and the position of the stabilizer at the moment of autopilot disengagement. The FDR recorded the stabilizer as moving in a narrow band about a value of 3.17 units until about 1:50:14. After that time, the stabilizer continued its movement around a value of about 3.3 units.

- The Mach trim system would have issued a command for nose up stabilizer during the initial dive from time 1:50:00 through 1:50:13 EST.
- The stabilizer did not move in response to the Mach Trim commands from time 1:50:00 through 1:50:13 EST. The lack of stabilizer trim movement during the initial portion of the dive is consistent with nose-up stabilizer trim being disabled by the elevator column cut-out switches.
- The indicated stabilizer movements beyond 1:50:14 would not be from the Mach trim system.
- Stabilizer movement (if any) after 1:50:14 could have been the result of manual electric trim input or stabilizer standby switches input.

Figure 33 Stabilizer movement time history, Mach trim computed command

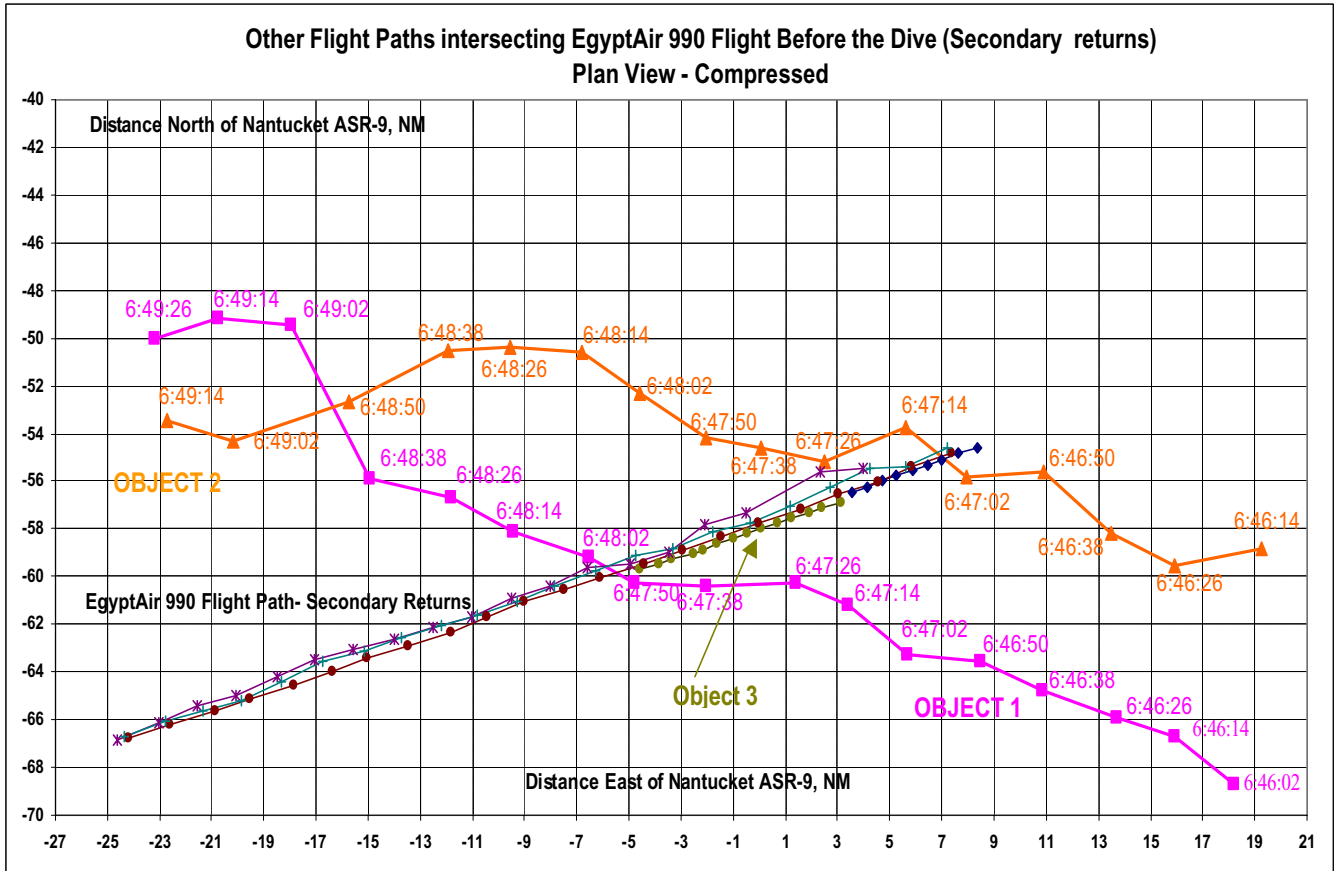
Figure 47 Continuous flight path returns meeting EgyptAir Flight 990

Figure 47 is constructed using the primary data from Riverhead (RIV) radar. The analysis of RIV primary data showed returns forming three continuous flight paths. Based on the limited information provided to the Egyptian team, it is believed that these paths are formed by real objects crossing the EgyptAir 990 flight path, with high ground speeds (about 1.4 Mach number).

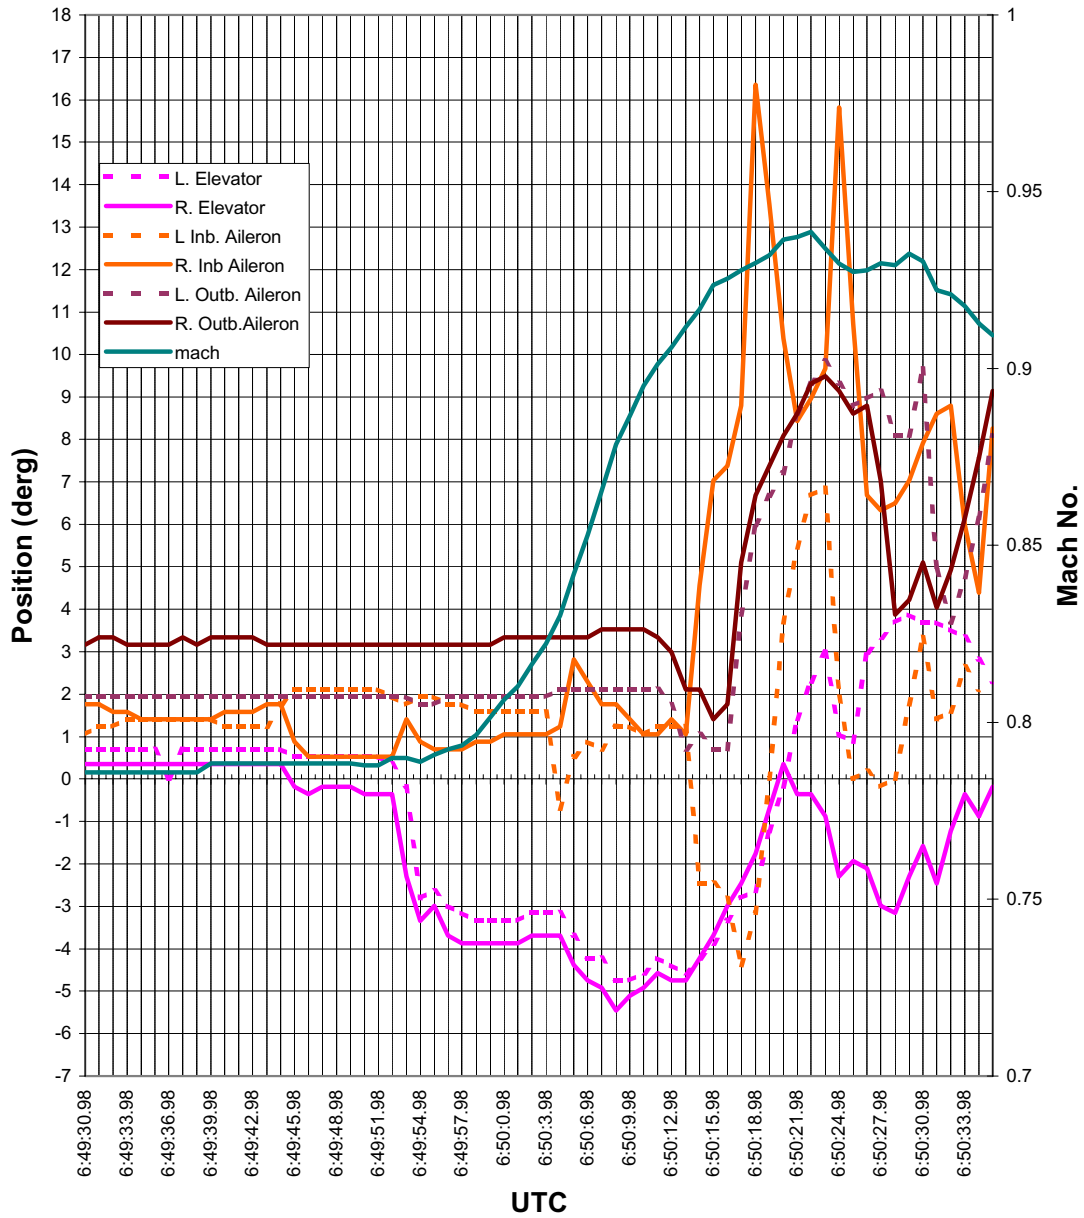
Figure A-2.1. FDR Elevator and Aileron Deflection and Derived Mach number

The results of the above analyses strongly suggest the possibility that some or the entire right elevator broke off some time shortly after the dive began. If that occurred, the information on right elevator position that was sent to the FDR is meaningless, and the argument that the recorded elevator split was due to a fight in the cockpit is simply wrong.

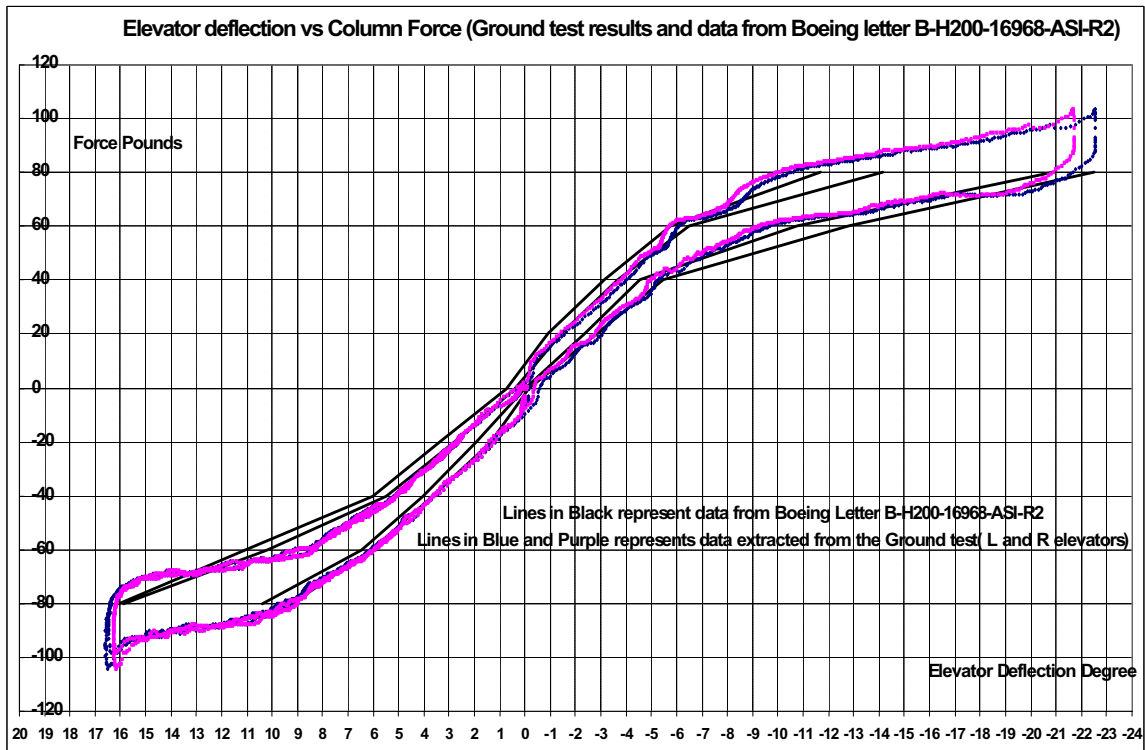
Figure A-3.1. Elevator Force-Deflection relationship (Ground test and Engineering data)

The ground tests results for the tests conducted on December 1999, for elevator sweep at normal condition (with elevator feel pressure 770 psi), did not show a close match with the charts presented by Boeing letter for evaluating the elevator failures conditions. Figure A-3.1 shows a comparison of the test results and an excerpt of the data provided by Boeing.³⁶

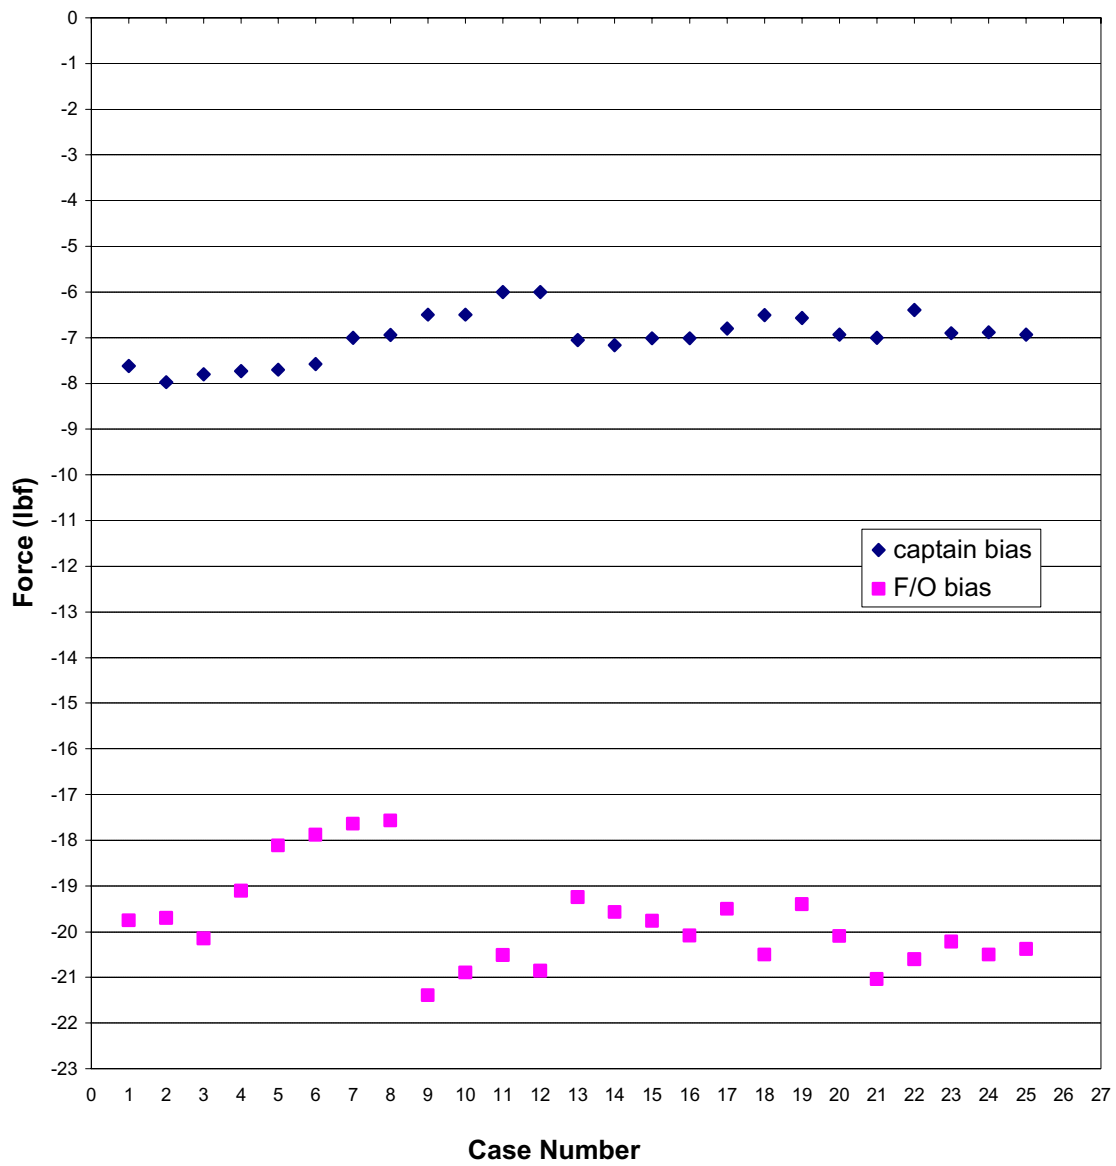
Figure A-3.2. March Ground Test Data, Bias Changes for Captain and First Officer Column Force Measurements

Further, Boeing's explanation of force bias due to temperature effects is not supported by the data. Figure A-3.2 shows the bias on the Captain's column force measurement increasing with time, with the suggestion that changes in temperature caused this change in bias. If temperature were the cause of the change in bias, the bias in the First Officer's force measurement would have increased as well, but instead, it decreased. In addition, the bias on the First Officer's force measurement does not change
